Fire Risk Assessment

Bonsal Village Hall

1 Yeoman St, Bonsal, Matlock DE4
2AA, UK
(53.1185069, -1.5845017)

09.02.2026

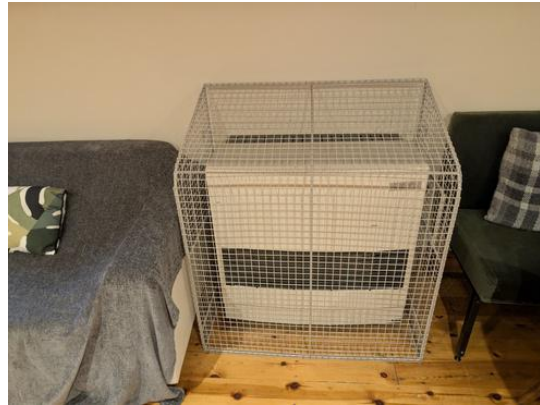
Photo 6

Heating is provided via three gas room heaters

The heating/ ventilation system is regularly maintained by a competent person

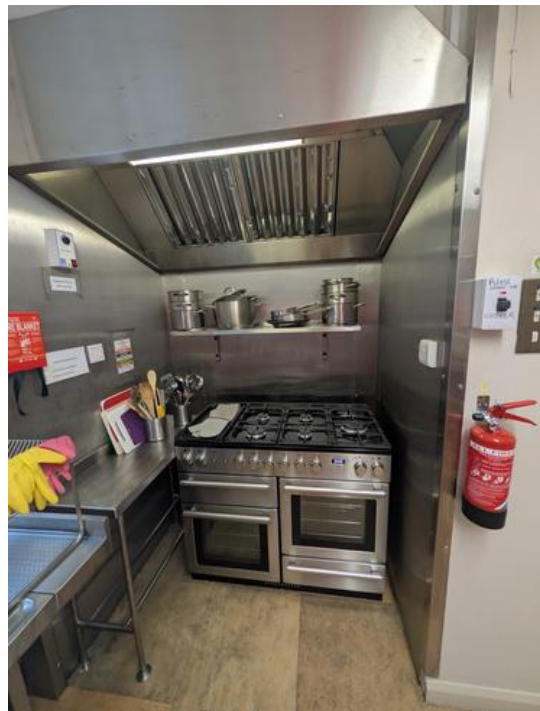
Photo 8

A full gas fired cooking range is sited in the kitchen

Ductwork is cleaned and filters are changed as necessary as part of the regular maintenance programme

Filters appeared clean and cookers are used irregu-

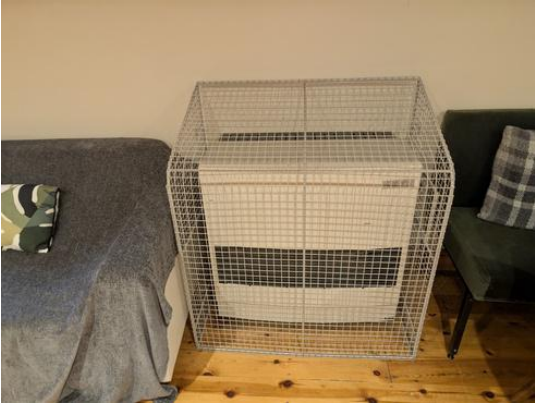
Photo 9

At least one gas heater is located very close to combustible furniture.

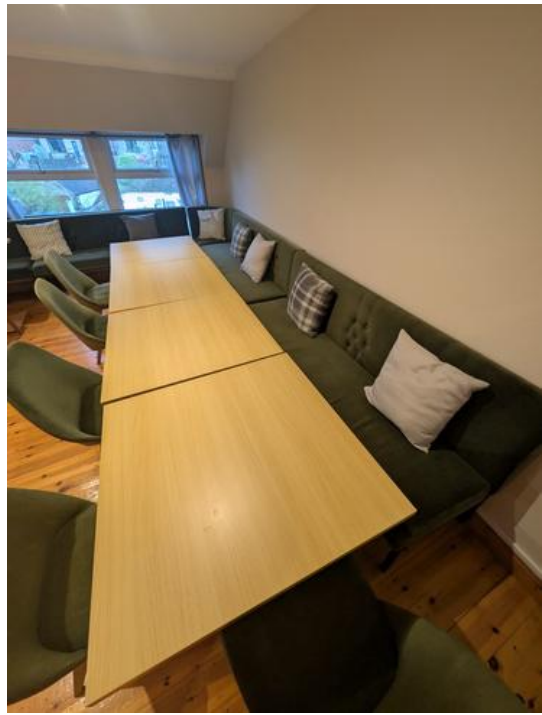
Photo 10

All furniture is approximately 10 years old and will therefore comply with the Furniture and Furnishing Regulations 1998.

Furniture appears to be compliant with the Furniture and Furnishing Regulations 1998

At the time of the inspection, soft furnishings appeared to be in good condition.
